# The Province House Demolition

By THOMAS T. WATERMAN

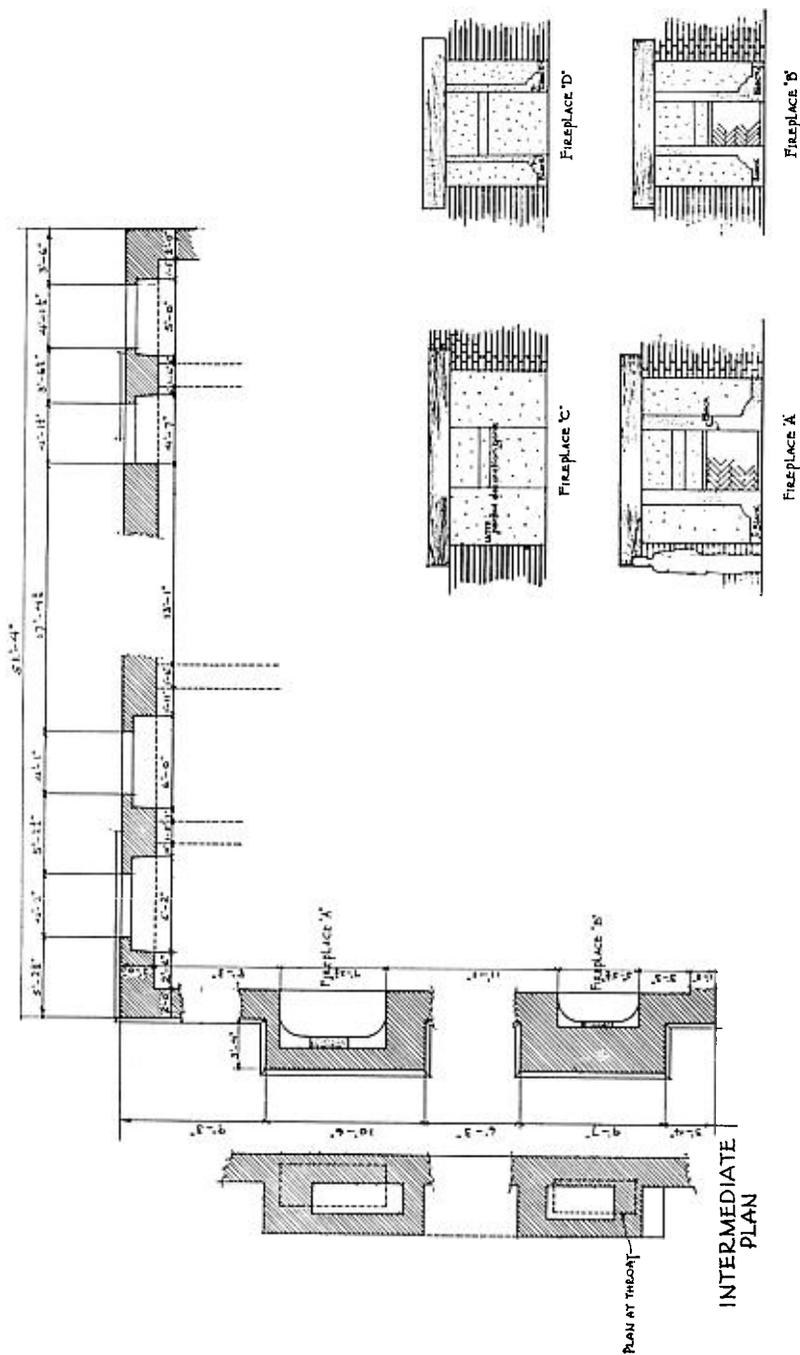
FIG. 6. THOMAS T. WATERMAN; MEASURED DRAWING OF FIRST FLOOR  
Fragmentary, recorded 1922.

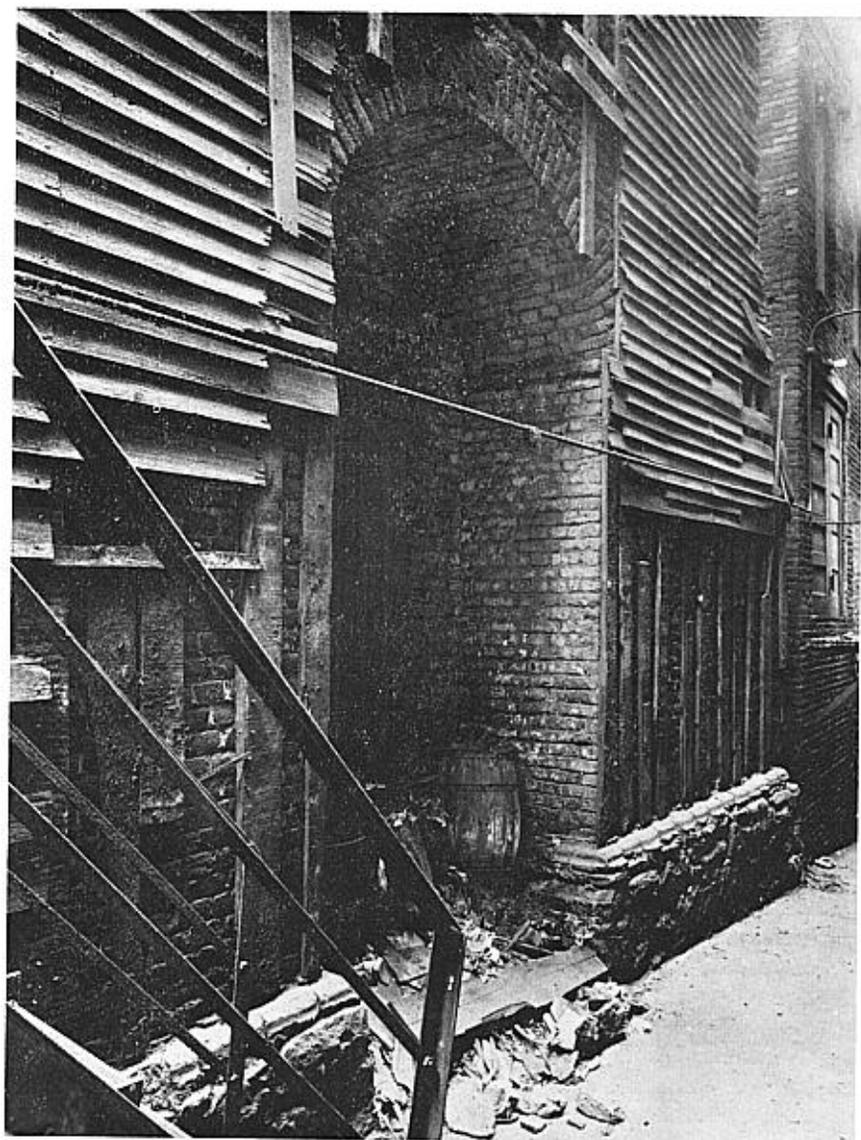
For many years the vast chimney, visible from an adjacent narrow alley, was familiar to architects and antiquarians, but its beauty and significance were not obvious under a covering of clapboarding. (Fig. 7.) It was found that on the removal of this veneer that the brickwork was in perfect condition, free from any indication of settlement or structural instability. The main feature

FIG. 7. DETAIL OF THE NORTH WALL VIEWED FROM THE EAST  
Photograph from the Society's collection, 1920.

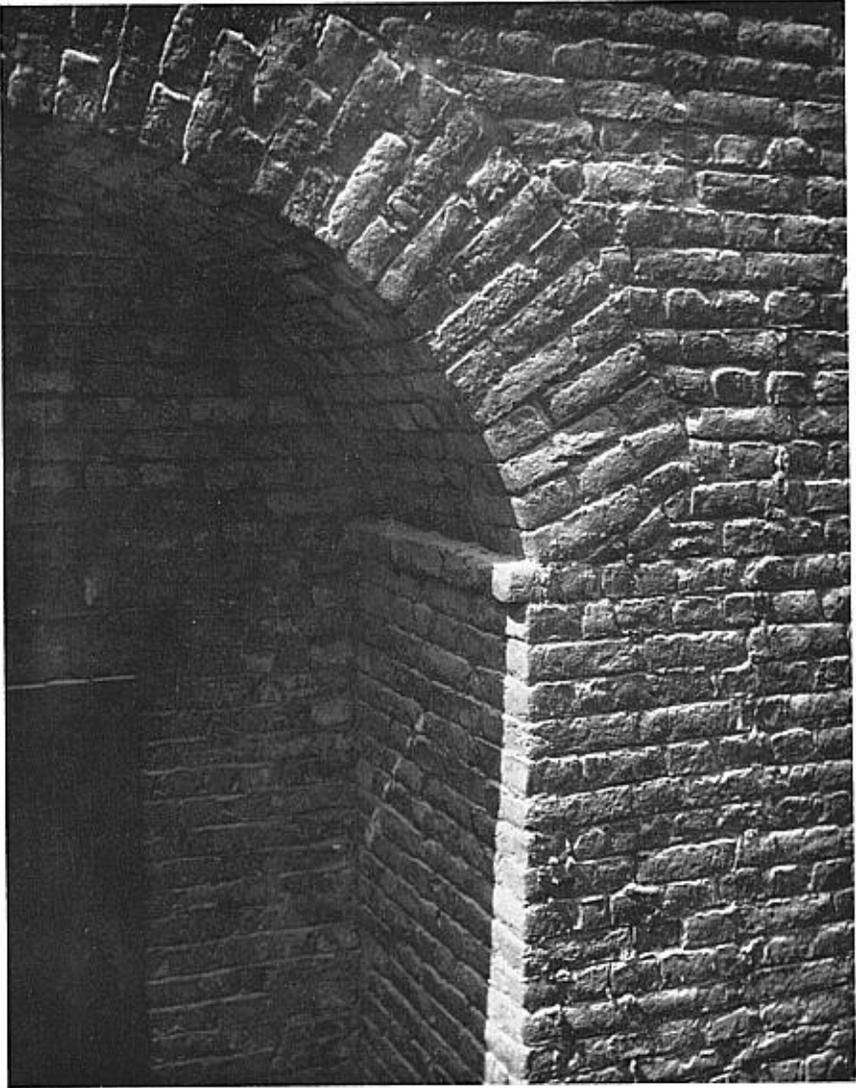
FIG. 8. DETAIL OF THE NORTH WALL ARCH AND IMPOST  
Photograph from the Society's collection, 1922.

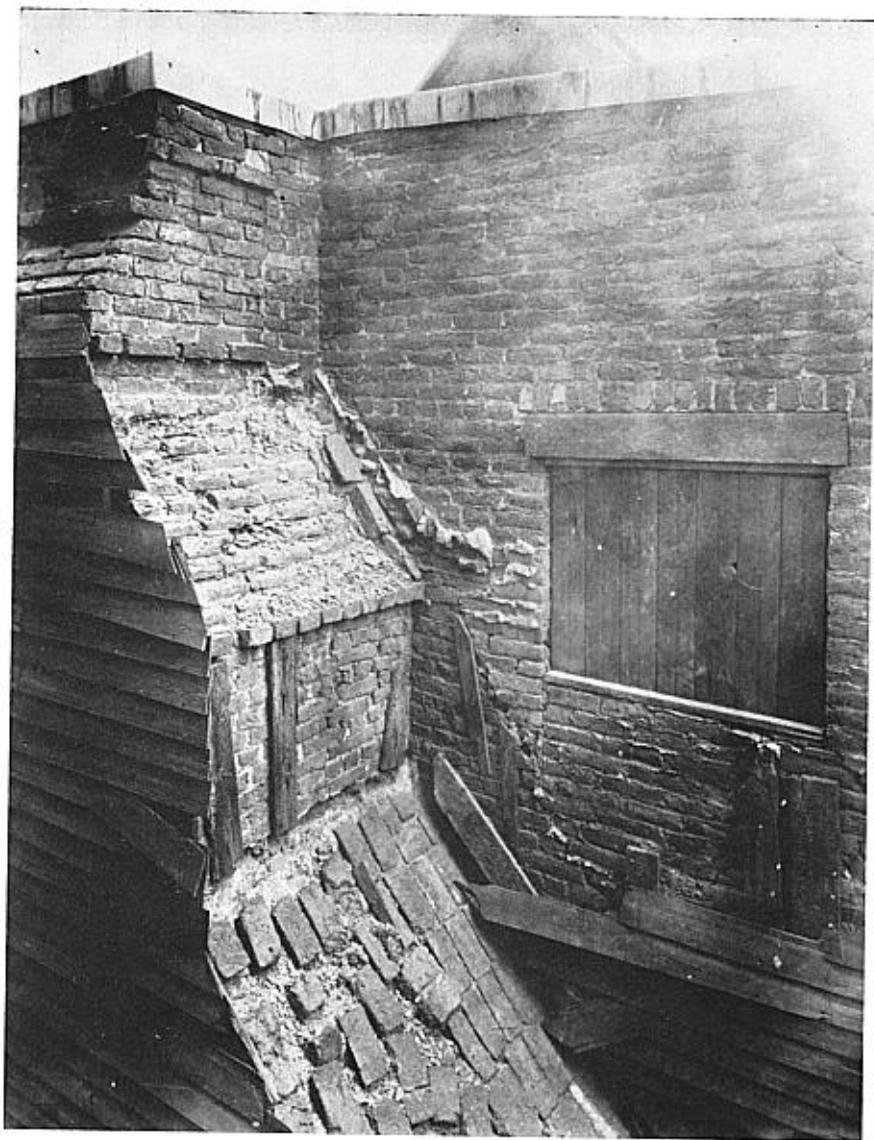
western offsets were all in excellent condition before the work of demolition began. The drawings indicate the location and ascent of the flues from the six fireplaces and show them to be of usual stepped construction. As shown, the six flues gather above the grade of the third floor forming a stack fourteen feet six inches by three feet nine inches, and for the first time a longitudinal offset occurred. This extended the entire length of the chimney, was four courses in height and of similar construction to latitudinal washes. This weathering was taken by a projecting course of stretchers and was surmounted by two projecting courses separated by two normal courses. (Fig. 9.) All evidence as to the termination of the stack was removed, perhaps when the modern flat roof was constructed, but fortunately some ten courses below this level was found the longitudinal offset just mentioned, near the point at which the chimney stack separated itself from the gable wall, ascending independently the remainder of its height. It will be seen on the photograph (Fig. 10) that the string courses at the line of the second and third and fourth floors were cut back flush to allow for the application of the clapboards, without leaving trace of their profiles.

FIG. 9. DETAIL OF THE CHIMNEY SHOWING OFFSETS  
Photograph from the Society's collection, 1920.

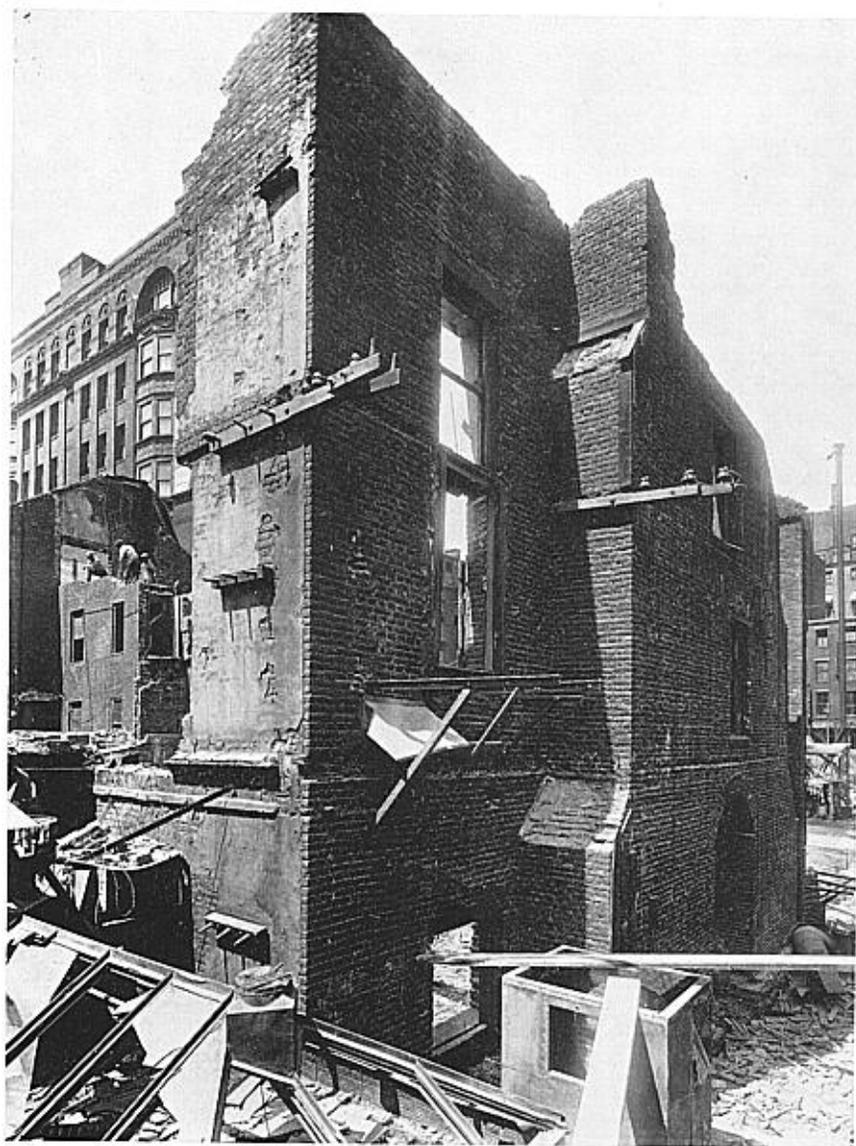
FIG. 10. NORTH WALL VIEWED FROM THE EAST DURING DEMOLITION  
Photograph from the Society's collection, 1922.
