To Keep an Old House in Good Standing

By ROY W. BAKER

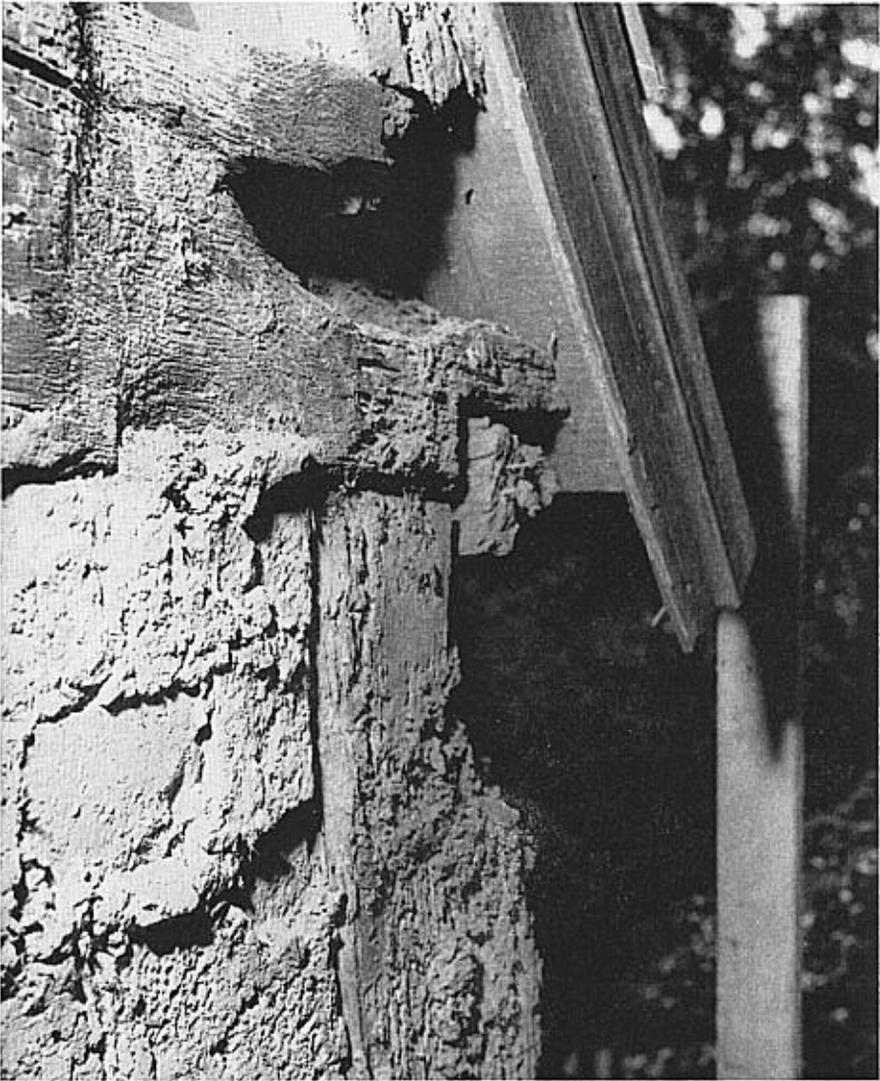
FIG. 1. INTERSECTION OF PLATE, CORNER POST, END GIRT AND RAFTER,
SEVENTEENTH-CENTURY CONSTRUCTION

Figure 1 shows the intersection of an end girt, front plate, principal rafter, and corner post. The corner post is not only responsible for the support of the end girt, plate and principal rafter, but also the ends of two second-floor girts a story be-

low, therefore assuming a vital importance for structural soundness at this point.

damage caused by termites and rot, the corner post was hollowed out, leaving only a shell which showed on the interior.

The house from which this illustration was taken, being seventeenth century in its construction, had its corner post (shown in this plate) exposed on the interior. In order to correct the structural

A new post of the proper size was inserted in this shell. The rotted part of the girt was removed, spliced and ironed together. The plate was repaired in the same way, and each new piece of wood

prepared to rest on the post in the same manner as the original timbers. The principal rafter, very badly rotted, was replaced entirely. This trouble spot was discovered, and uncovered, because of broken plaster and the bulging of the plate shown in figure 2.

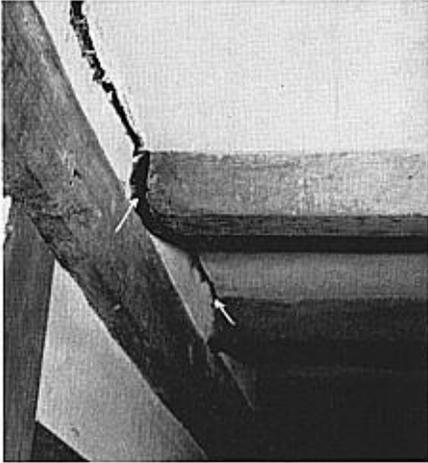
FIG. 2. INNER FACE OF END GIRT SHOWN IN FIG. 1 WITH FLOOR JOISTS AND CEILING ABOVE, PLASTERED BETWEEN THE JOISTS

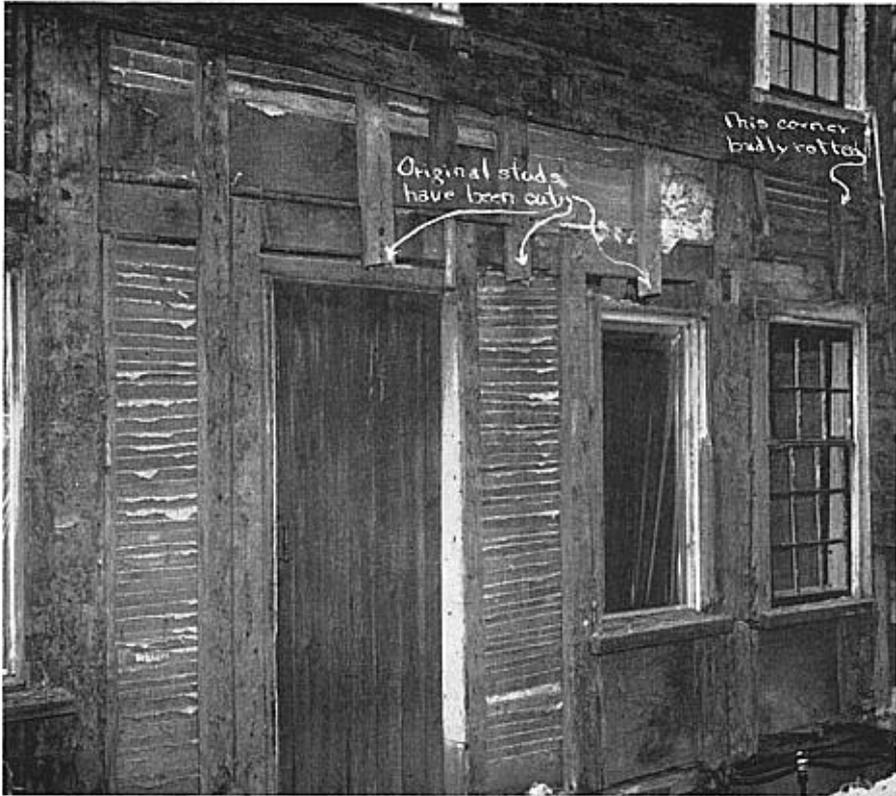
FIG. 3. EXTERIOR WALL SHOWING POSTS AND STUDS (OR SIDE BEARERS) CUT OFF BELOW GIRT, SEVENTEENTH-CENTURY CONSTRUCTION

Figure 3 illustrates an exterior wall which had every sign of improper support. When uncovered, as may be seen, original studs (or in this case side-bearers) were revealed as having been cut off. In places the sill was completely rotten and the post and girt in bad condition. Financial restrictions and practical reasons made it necessary to leave the windows and

door shown in this figure in their present positions. This meant that the procedure here involved replacing the sill, patching and splicing the girt, and putting in new studs in new positions to give the added support necessary in order to make this wall structurally sound.

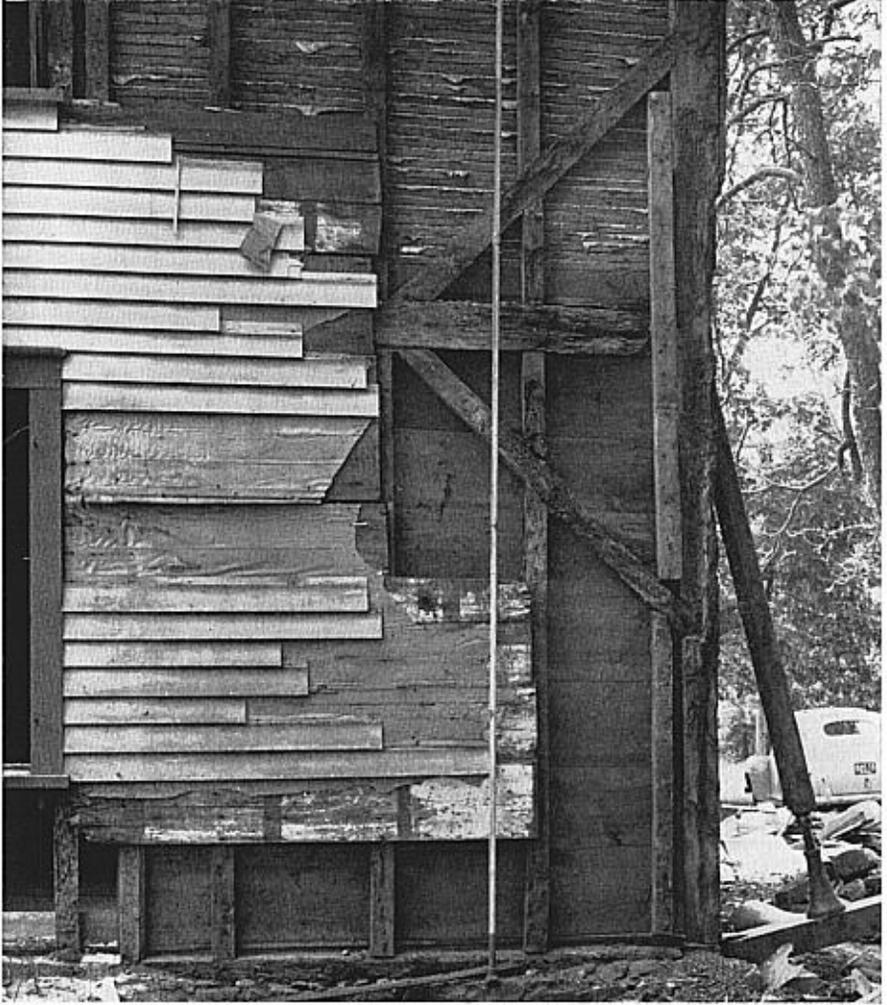
FIG. 4. EXTERIOR WALL SHOWING CORNER POST, GIRT, STUDS AND BRACES, AND SILL, EIGHTEENTH-CENTURY CONSTRUCTION

Figure 4 shows a corner of a mid-eighteenth-century house which, before it was uncovered, revealed a definite sag and bulge at the second-floor level. It is clear in this picture that the corner post is structurally unsound. The first-floor corner brace and the second floor girt are rotted and not supported by the post, and an original 8 x 8 sill has practically disappeared. This damage was entirely owing to rot from moisture. To repair the situation a new sill was required; the corner post was cut out, filled and spliced, and a new corner brace was installed to replace the rotted one. The second-floor girt had all its rotted wood removed, was spliced, and fastened securely to the remainder of the girt and corner post.
