Asher Benjamin's West Church: A Model for Change

NANCY S. VOYE

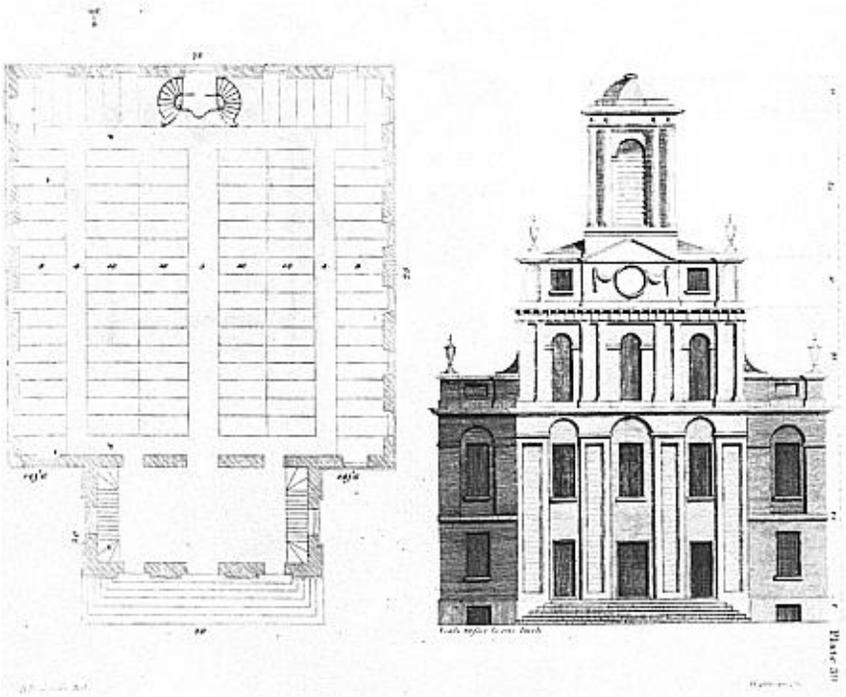
FIG. 1. FLOOR PLAN AND FRONT ELEVATION, WEST CHURCH, from Asher Benjamin's *The American Builder's Companion*, 1806. (Photo SPNEA.)

Benjamin's first major commission in Boston. Not only is the West Church central to a study of Asher Benjamin as a stage in his architectural career in Boston, but also as a model which Benjamin proposed for adoption by other builders. In his first edition of *The American Builder's Companion*, published in 1806, Benjamin included sketches of the front facade of the Church, its floor plan, roof structure, and pulpit design (Figures 1 and 2). In addition, Benjamin furnished the following description of the West Church:

The size of the house is seventy five feet square, porch twenty by forty six feet; to contain one hundred and twelve pews on the lower floor. The gallery is supported by columns of the Composite order, as laid down in this book.²

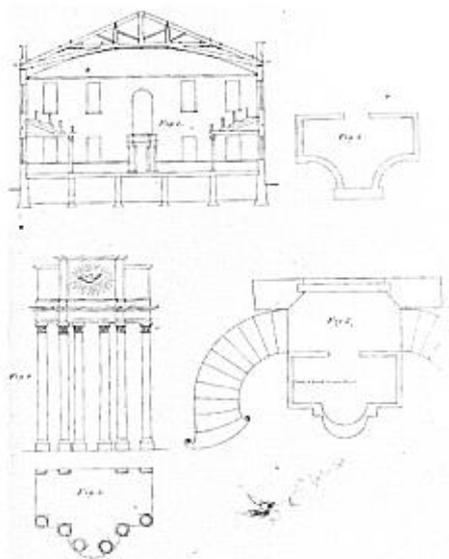
FIG. 2. SECTION AND DETAILS, WEST CHURCH, from Asher Benjamin's *The American Builder's Companion*, 1806. (Photo SPNEA.)

(Figure 3). The difference between the 1806 and 1823 roof trusses is striking. The 1806 truss system employed only one queen post to each side of the king post, and its component parts were held together by iron bolts (Figure 2). In contrast, the 1823 truss system is composed of a king post with two queen posts on each side; early nineteenth century numbers distinguish those elements of the truss system which are to be joined to each other (Figures 4 and 5). Additional evidence of the 1823 alteration of the roof can be found by examination of the rear wall of the Church. The demarcation between the 1806 and 1823 roofs is made visible by the smaller size and less regular shape of the handmade 1806 bricks.

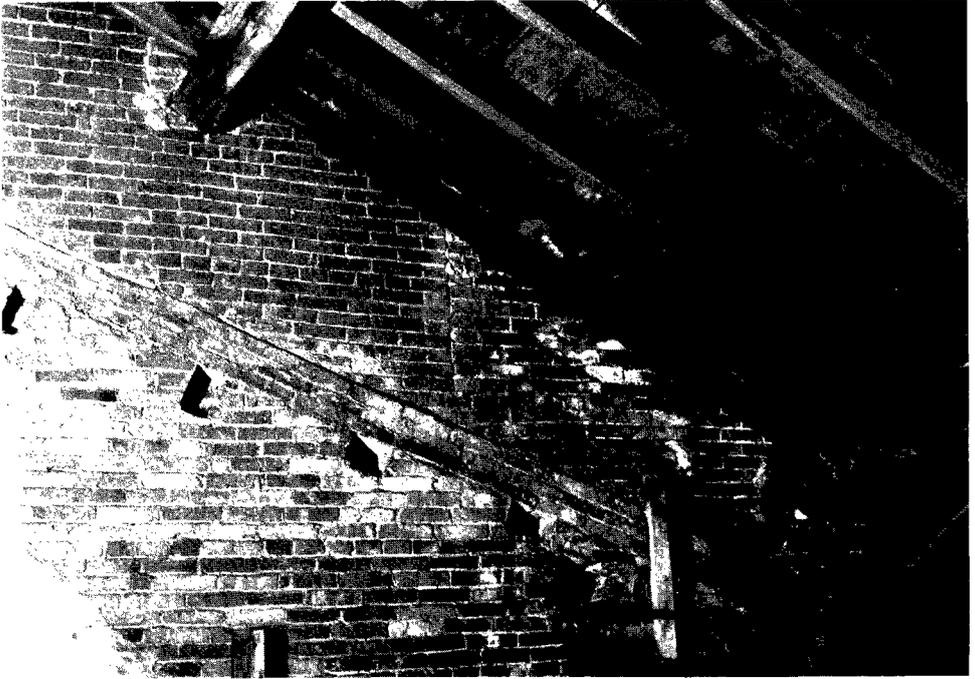
FIG. 3. INTERIOR FRONT WALL OF WEST CHURCH, ABOVE THE CEILING. Note the original roof line and purlin holes. (Photo by William W. Owens, Jr.)

Though the Society had evinced a reluctance to disrupt what they perceived as the harmony of the elements in Benjamin's design, it was not similarly inhibited when it decided to raise the roof in 1823. In his 1806 edition of *The American Builder's Companion*, Benjamin described and included a sketch of the roof structure which supports a dome ceiling "of forty two feet in diameter, which rises six feet."⁷ However, an examination of the present roof structure reveals that the roof has been raised approximately forty-two inches, with the holes for the original purlins still visible

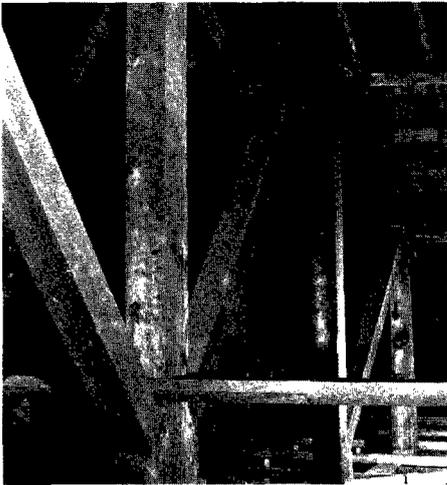
FIG. 4. KING POST (left) AND QUEEN POSTS (right), WEST CHURCH. (Photo by William W. Owens, Jr.)

Not only is there a variety in the methods of joining units, but also in the sawing techniques. Examples of pit sawn, hand hewn and up and down sawn timbers are found in the roof structure (Figures 4 and 8). The haphazard pattern

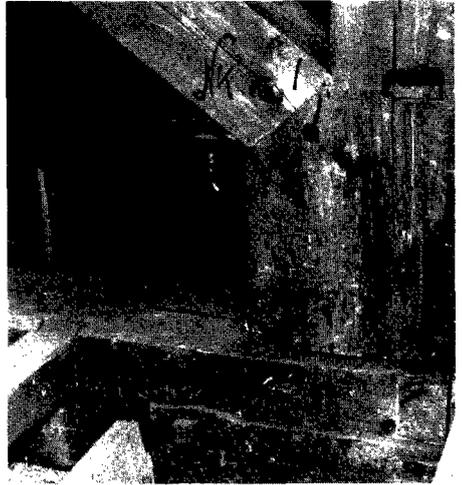
FIG. 5. DETAIL OF BUILDER'S NUMBERS, ON ROOF FRAME TIMBERS, WEST CHURCH. (Photo by William W. Owens, Jr.)

span; instead, two timbers are joined by a bladed scarf joint, which is five feet in length and secured by a six foot iron bolt (Figure 7). The bladed scarf joints and the numbering and lettering of matching roof members have much earlier precedents in seventeenth century English and American framing. However, the style of the letters and numbers clearly dates the roof to the early nineteenth century (Figure 5).

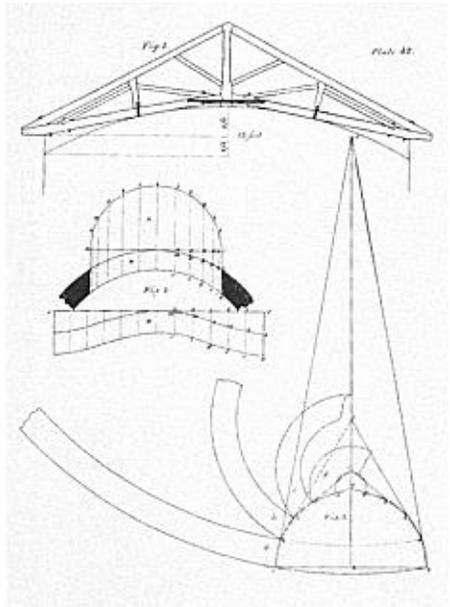
FIG. 6. PLANS FOR A ROOF SUPPORTING A DOMED CEILING, from Asher Benjamin's *The American Builder's Companion*, 1827 edition. (Photo SPNEA.)

Significantly, while the West Church's front facade and floor plan are reproduced in the 1811 edition, the roof elevation of the Church has been omitted in the second edition. In this 1811 edition, Benjamin again responds to the problem of supporting a domed ceiling; but he now proposes an entirely different model than that which he represented in his 1806 guidebook. In the 1806 model, the king and queen posts are framed into a single, horizontal tie beam (Figure 2); in the 1811 modified scissor truss system, the tie beam is formed from two timbers that meet at an angle at the king post (Figure 6).

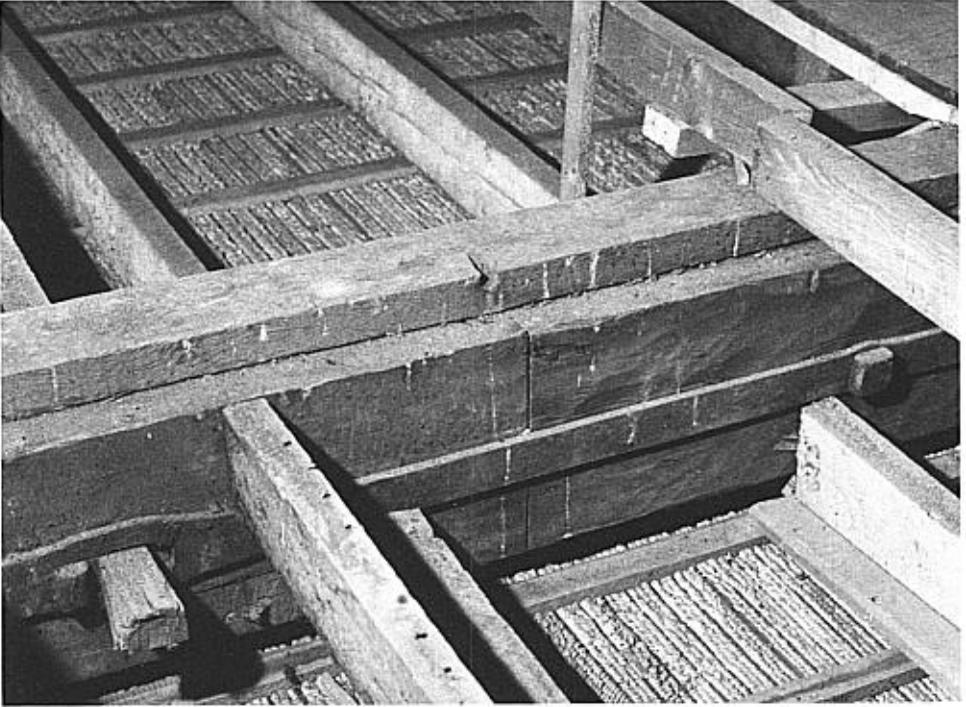
FIG. 7. DETAIL OF TIE BEAM, SHOWING SCARF JOINT AND IRON STRAP, WEST CHURCH. (Photo by William W. Owens, Jr.)

Even without the complete alteration of its roof structure in 1823, the West Church would be an interesting, as well as an informative, model of early nineteenth century building techniques. The tie beams are not a single piece of timber stretching across the seventy-five foot

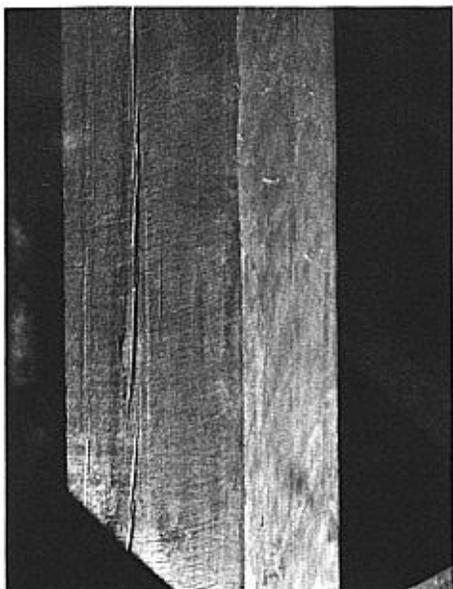
FIG. 8. DETAIL OF QUEEN POST, SHOWING PIT SAW MARKS. (Photo by William W. Owens, Jr.)

of saw marks slashing across the surface of the wood of the queen posts are characteristic of pit sawing (Figure 8). The split in the lower end of this queen post suggests that the post was pit sawn up to this point and was then split the rest of the way.
