OLD-TIME NEW ENGLAND

BULLETIN OF THE SOCIETY FOR THE PRESERVATION OF NEW ENGLAND ANTIQUITIES

St. Michael's Church, Marblehead, Massachusetts, 1714

By STUART PAUL FELD

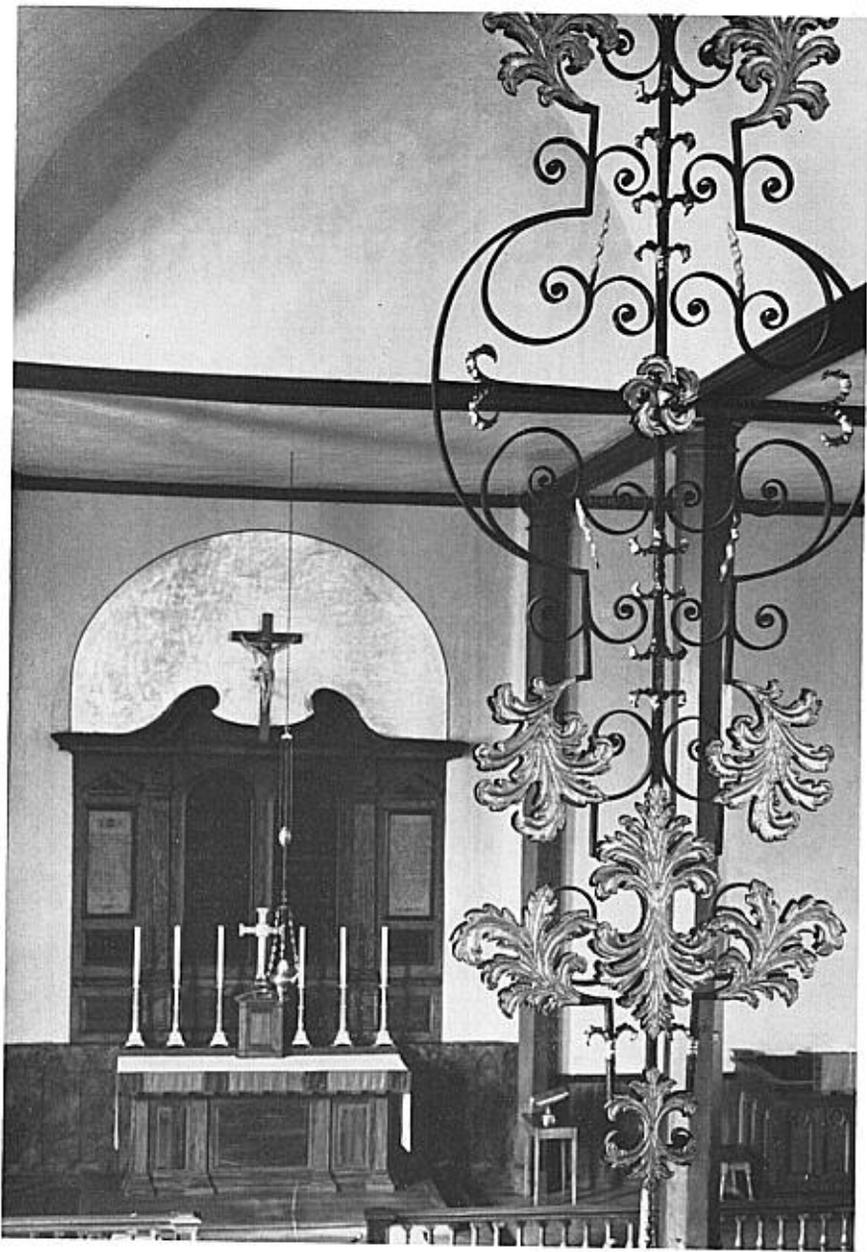
ST. MICHAEL'S, DETAIL OF WROUGHT IRON SUPPORT FOR CHANDELIER
Courtesy of Samuel Chamberlain.

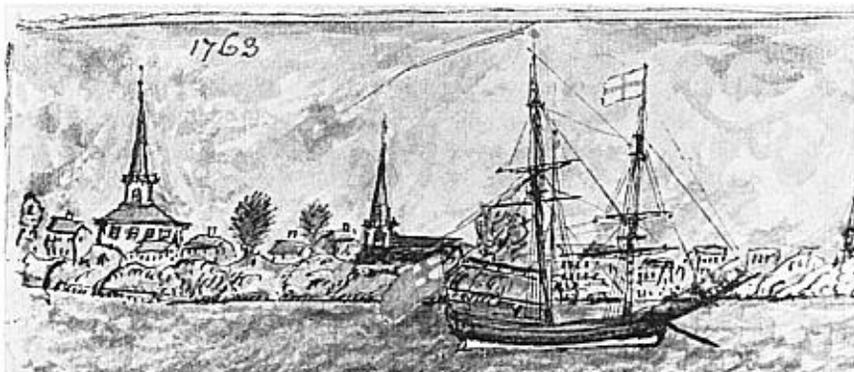
WATER-COLOR VIEW OF MARBLEHEAD, 1763, SHOWING ST. MICHAEL'S CHURCH AND SPIRE AT LEFT

The Bowen drawing indicates only the general outlines of the design, which consisted of a simple tapering spire, probably four or six sided, surrounded by a balustrade and set upon the existing tower.⁵ Moreover, this sketch confirms the author’s opinion that the present Palladian openings in the tower—which first appear in the 1818 drawing—are not a part of the original design, but rather represent a later embellishment of the single round-headed windows which are shown in the Bowen drawing and which represent the standard of early eighteenth-century practice. An investigation of the interior construction of the tower reinforces this theory, for the supporting braces have

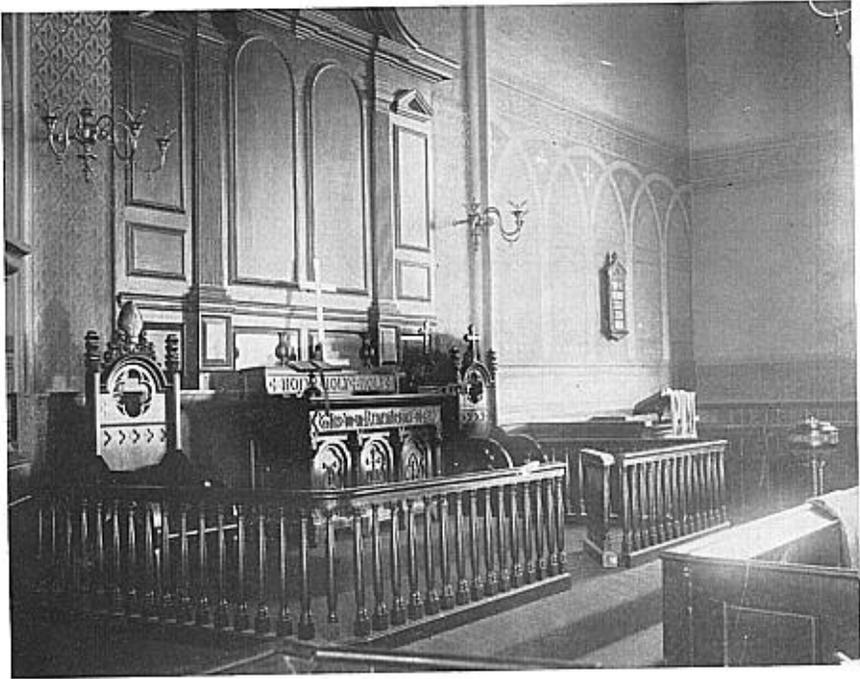
INTERIOR OF ST. MICHAEL'S (LOOKING NORTH), LATE NINETEENTH CENTURY

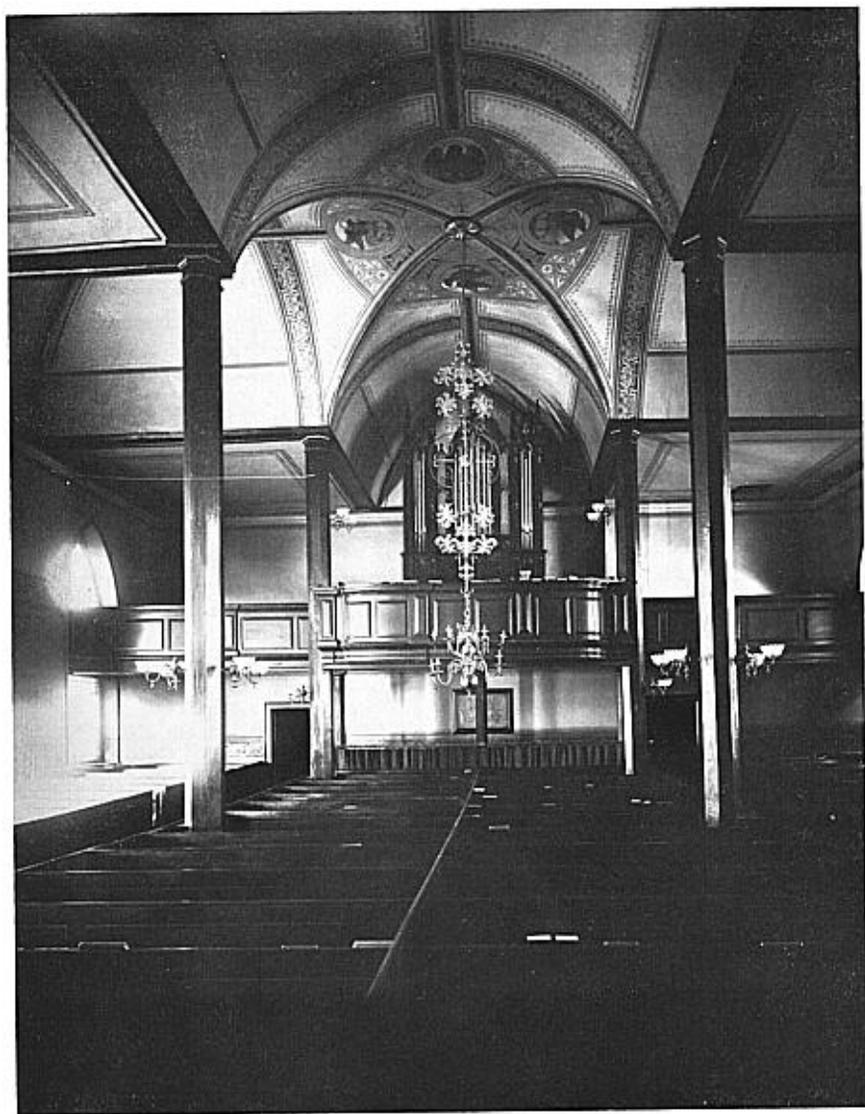
INTERIOR OF ST. MICHAEL'S (LOOKING SOUTH), *ca.* 1888
Courtesy of the Essex Institute.

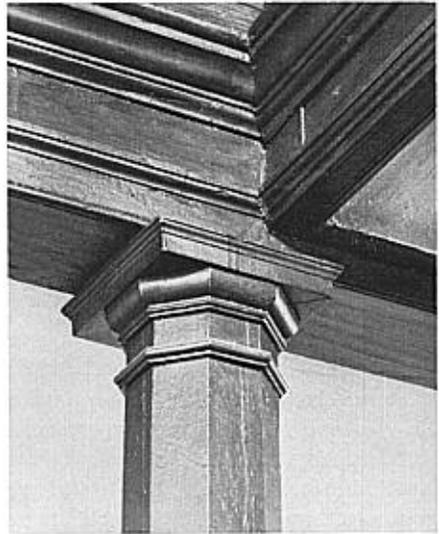
ST. MICHAEL'S, DETAIL OF COLUMN AND CAPITAL SUPPORTING THE GALLERY

²² Church Records, I, 48, 51, 30, 39-40, and II, 92. The gallery is supported by five, solid, octagonal columns, which carry out the basic design of the four central piers. Although the placement of two of these was changed at one time, apparently in 1833 when the present slip pews replaced the earlier box pews, their original positions can be readily distinguished on the basis of cuts and markings along the base of the paneled gallery front. These two supports are hollow and appear to be later replacements. An old tradition holds that the two original posts were used as supports for the south porch, but existing evidence does not ratify this. [Hodgkinson, *op. cit.*, p. 5.]
