The Thompson, Connecticut Bank

By JOHN OBED CURTIS

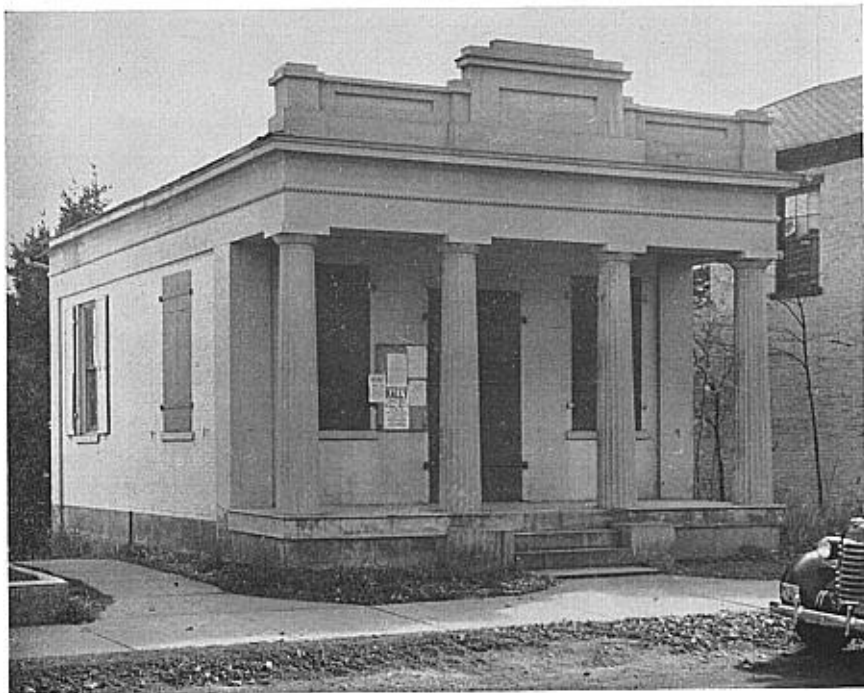
THOMPSON BANK, BUILT ABOUT 1835

Photograph about 1938, courtesy of Old Sturbridge Village.

The banking house which the directors of the Thompson Bank caused to be built is a charming compact little Greek Temple measuring approximately 22 feet across the front and 28 feet deep. In plan it is prostyle-tetrastyle, which means simply that it has four columns across the front carrying a portico. It is fitting certainly that a prosperous and up-to-date community would select the then popular Greek Revival for its imposing bank, for the decades of the 1830's and 1840's were the heyday of the Greek architectural idiom and no New England town is without its public and domestic structures in the Greek mode. The original flat pediment of the bank, which will be replaced in the restoration at Sturbridge Village, is perhaps somewhat overpowering for so small a building, but it provides a pleasing example of back country interpretation of the classical style. Emphatically horizontal in its design, it is intended to give the building a feeling of solidarity and mass as befits a bank. The spacing of the central unit with its recessed shadow panel, flanked by similar but less tall units terminating

in capped box-like posts, repeats and complements the intercolumniation. The general over-all feeling of the original pediment is one of projecting and receding planes, contrived by the architect to make light and shadow work for him in decorating the building. Asher Benjamin, one of our foremost nineteenth-century New England architects, explains this technique at some length in the preface to his *Practice of Architecture* of 1833.
