# The Province House, 1922

By WILLIAM SUMNER APPLETON\*

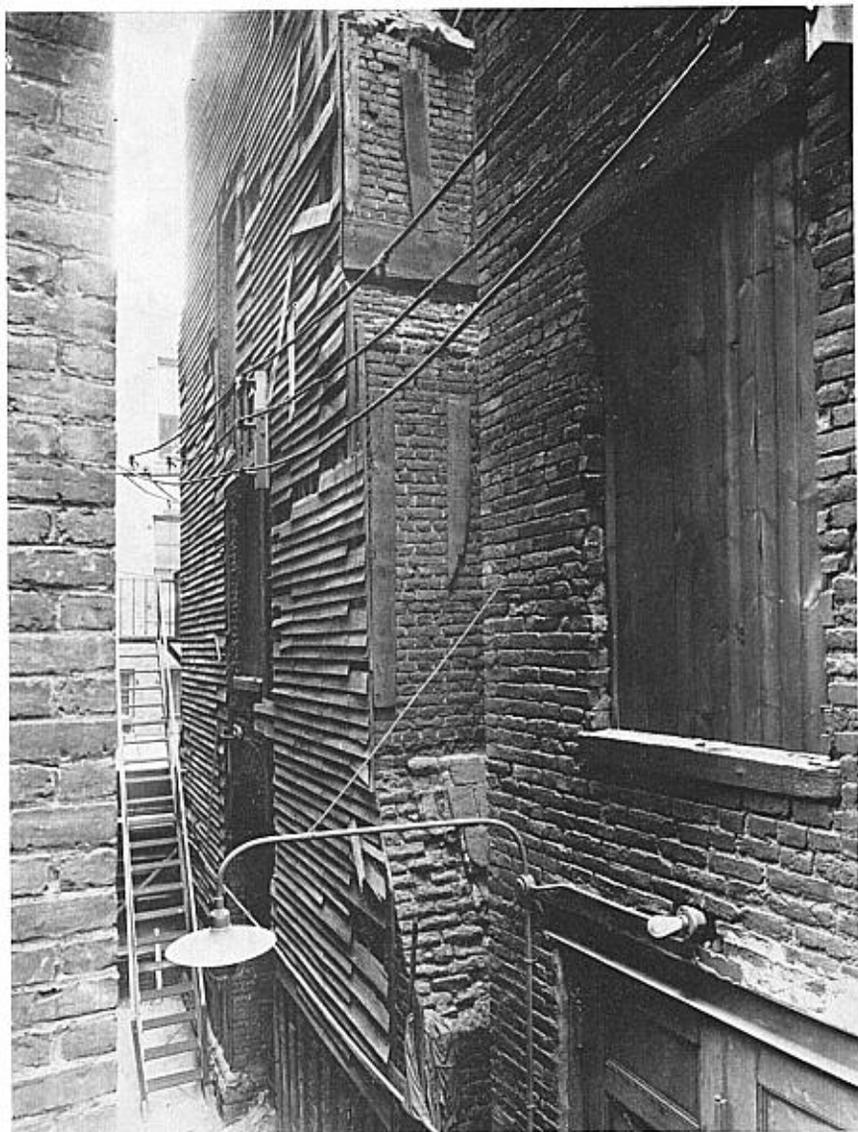
FIG. I. NORTH WALL VIEWED FROM THE WEST  
Photograph from the Society's collection, 1920.

The south wall was mostly hidden by buildings butted against it, but showed clearly that it suffered badly in the course of various alterations. The north wall, however, had come down practically intact and was almost wholly composed of an enormous stepped chimney of brick, projecting some four feet from the body of the house and divided at the first-floor level by a large arch. The whole northern face of this chimney was covered with clapboarding and was to be seen only from the narrow alleyway on which it abutted. (Fig. 1.) From within there were no fireplaces visible and the structure and contents of the chimney were largely a matter of guesswork. To be told that this was a true "Tudor" chimney, and one of the best of the very few standing in America, meant little to the writer or, so far as he has been able to ascertain, to anyone else of a generation ago.

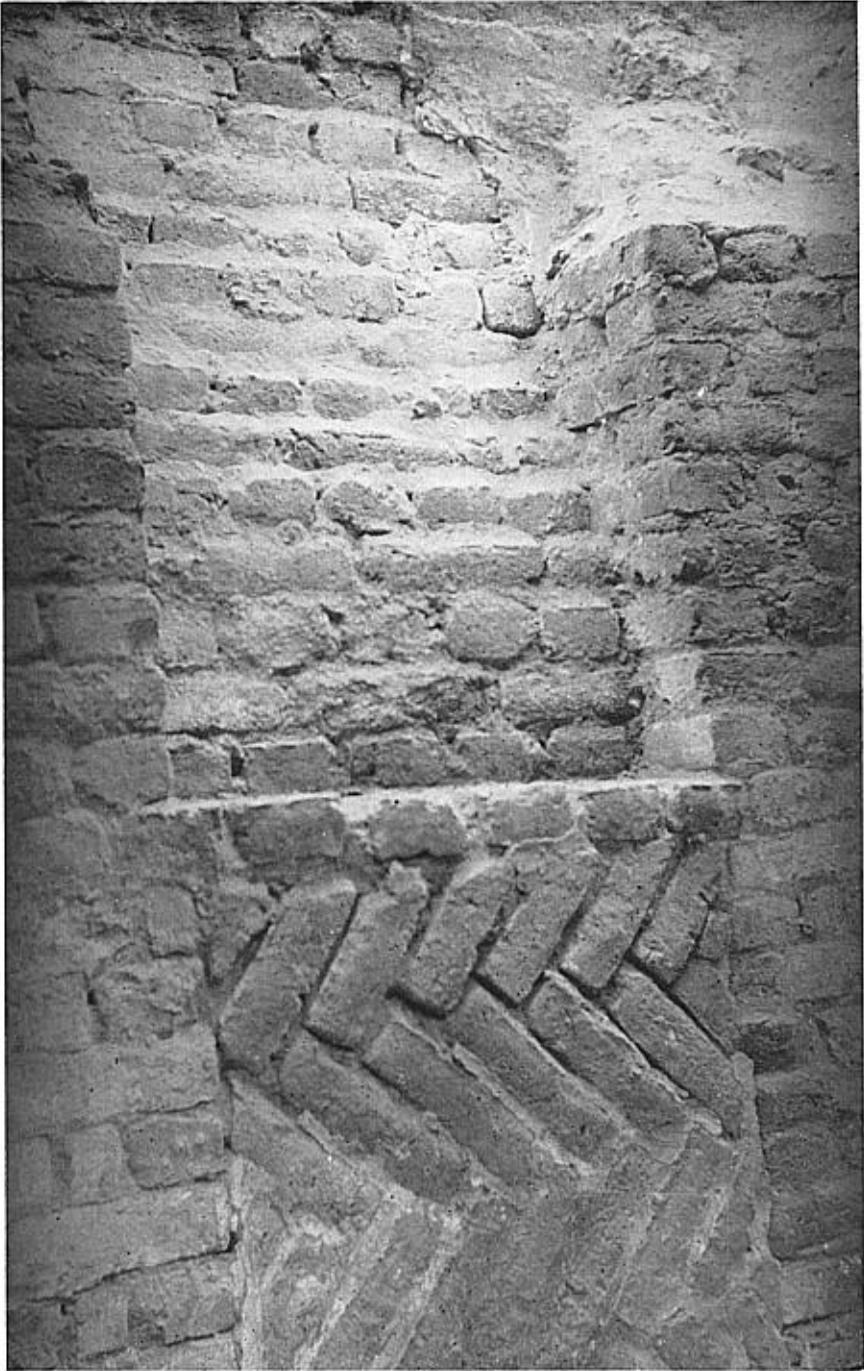
FIG. 2. DETAIL OF FIREPLACE, FIRST FLOOR REAR ROOM  
Photograph from the Society's collection, 1922.

This was a startling discovery in itself, but still more so was the fact that all six fireplaces were found in place and in at least as good condition as fireplaces of the seventeenth century are apt to be found hereabouts. The third-floor fireplaces were small affairs, as would befit rooms situated in that floor. The second-floor fireplaces were a revelation. That in the rear measured 5 feet 4 inches wide and 4 feet 6 inches high with a depth of 1 foot 9 inches. Rising from the hearth level and about a yard across the back was a herring-bone panel usually found in the fireplaces of the Bay Colony. The fireplace in the second story front room, contrary to all known New England precedence, exceeded in width those on the ground floor. It was 7 feet 6 inches wide, 4 feet 2 inches high and 2 feet deep with

a handsome herring-bone panel at the back. Evidently, this must have been the finest room of the house and later the Council Chamber of the colonial governors. So fine was this room that when at a later date the fireplace was diminished in size, making one of but 6 feet 2 inches wide, it must have still remained one of the most pretentious in New England, with jambs solidly covered with blue on white tiles and covering a space 1 foot 4 inches by 4 feet 2 inches on each jamb, and with an elaborate iron fireback between. The ground-floor fireplaces of the Peter Sergeant and Province House were by no means small. That in the rear being 4 feet 8 inches high by 5 feet 4 inches wide and 2 feet 3 inches deep; the fireplace in the front room being 5 feet 2 inches high by 7 feet 2 inches wide and 3 feet 9 inches deep.

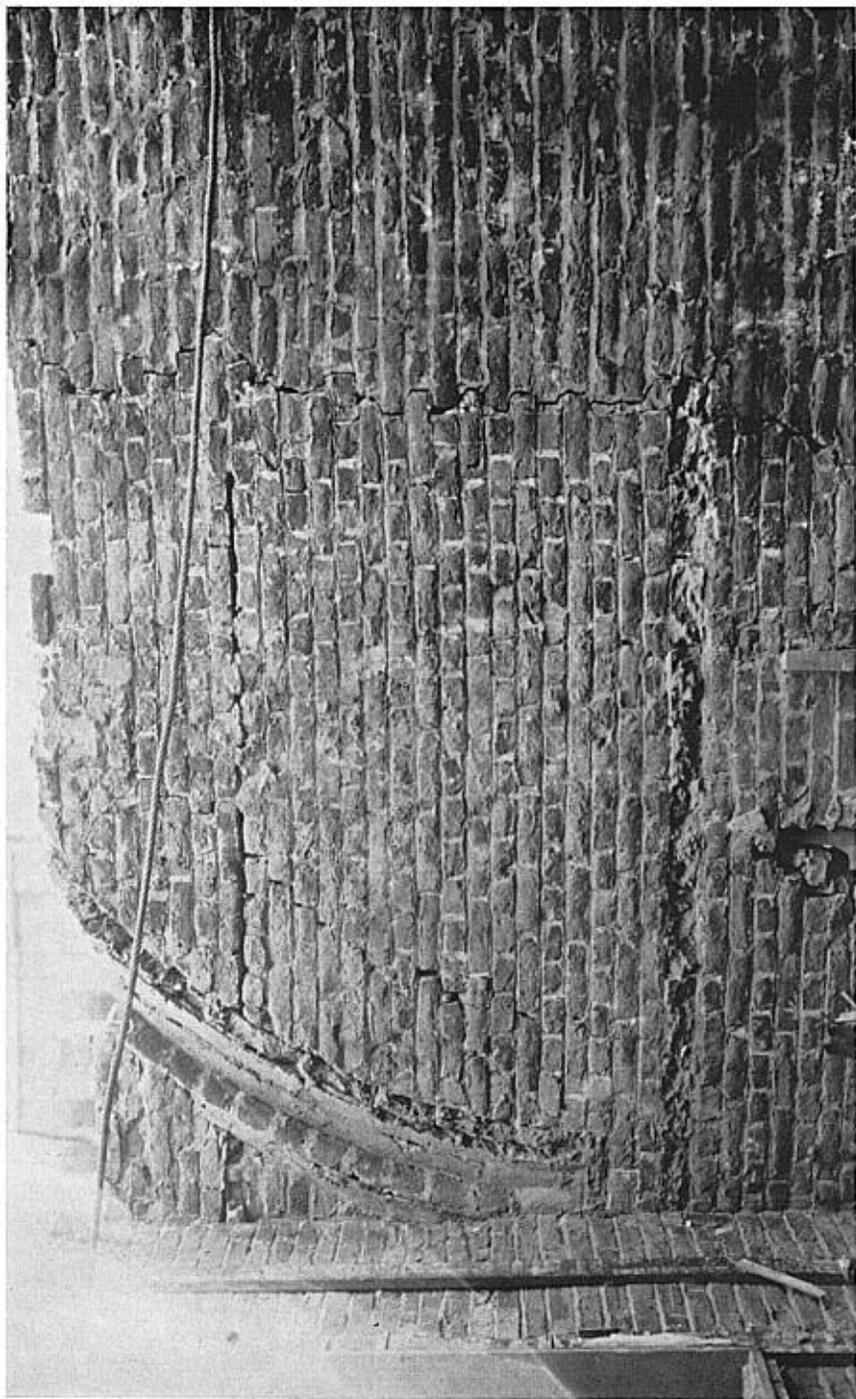
FIG. 3. DETAIL OF SOUTH GABLE, SHOWING THE CURVE OF THE ORIGINAL COPING  
Photograph from the Society's collection, 1922.

masked the straight line of the gable and the edge of this coping was formed of three varieties of molded brick. So far as the writer knows, nothing like this has been found elsewhere in New England and the only surviving example of such a curved brick coping for a gable end in America is at Bacon's Castle, Surry County, Virginia.

The other and much more elaborate molded brick may have come from a cornice at the level of the third-story floor on which probably rested smaller versions of such curved brick copings, and which masked the straight lines of the dormer fronts. Doubtless other molded bricks, and many of them enough for each flue, were used in the chimney tops, which were very likely destroyed in 1728. There is every reason to believe that at one point, namely around the window openings, molded brick was plentifully used. One such window opening in the south wall was found intact in part, at least, but seen only at night time by the wreckers. From their accounts it was evidently something unique in New England history, but its reconstruction must ever remain a matter of guess work. That this is not, fortunately, the case with the elaborate curved coping of the south gable is due to the fact that Mr. Philip L. Spalding, then Director of the Museum of the Society for the Preservation of New England Antiquities, happened along when its destruction was only in part completed. He immediately recognized the value of the discovery. A photographer of the *Boston Post* was fortunately present and was able to picture this coping, while the Society's draftsman, Mr. Thomas T. Waterman, arrived just in the nick of time to measure and draw the discovery. (Fig. 3.)
